# Manhole Inspection Summary

Manhole # S02UU1016MH

Insp Date: **7/31/06 10:13 AM**

**Location** Address: **6201 HOPETON AVE**

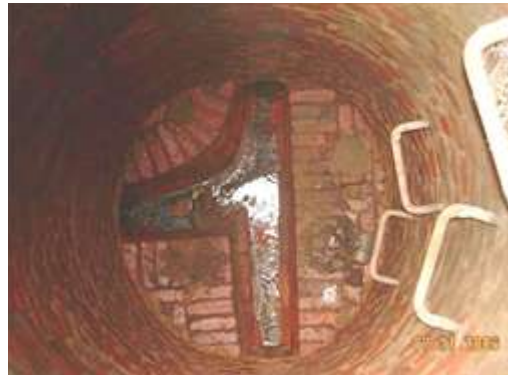
Top View

Adjustment, Corbel and Barrel infiltration.  
Evidence of surcharge - Bench debris.  
Channel debris.

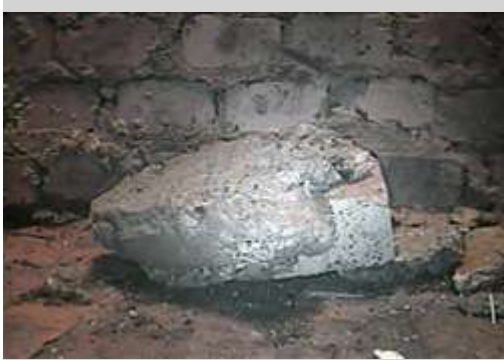
Defect

Barrel deterioration and infiltration. Bench debris.

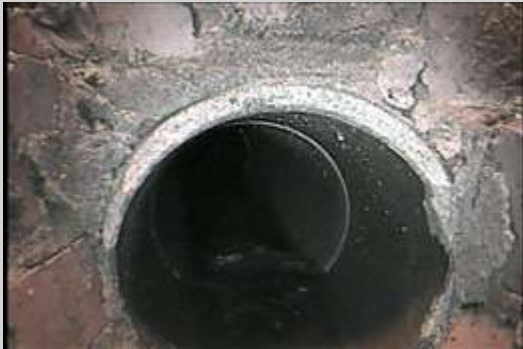
### 8 in. Circular Gravity Sewer Pipe Out @ 12 O'Clock

Deposits: ☐ None ☐ Mud ☐ Sludge ☒ **Debris** ☐ Grease

Silt Depth: **0.5** (in.) Deposits Extent: **Light**

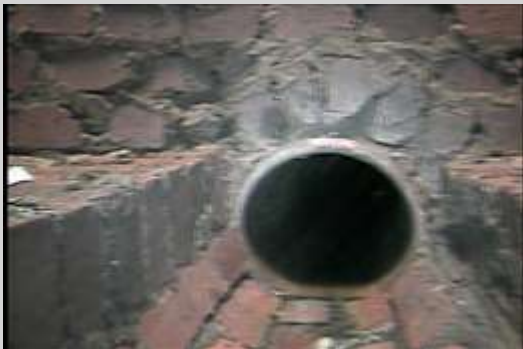
### 8 in. Circular Gravity Sewer Pipe In @ 6 O'Clock

Barrel and Channel deterioration.

Infiltration: **Evidence** Pipe Seal Cond: **Unknown**

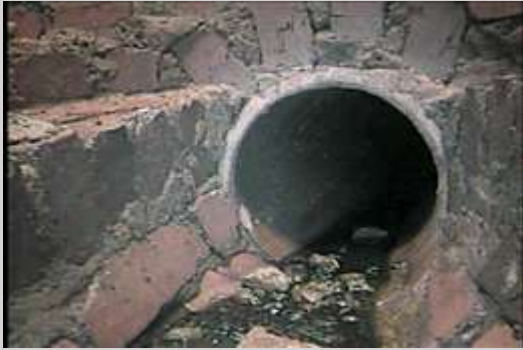
Pipe In @ 9 O'Clock

Deposits: ☐ None ☐ Mud ☐ Sludge ☒ **Debris** ☐ Grease

Silt Depth: **0.5** (in.)
